**TÜV Rheinland Energie und Umwelt GmbH  
Renewable Energies**

## **Test Report**

**Mechanical Load Test  
according to IEC 61215:2005**

**TÜV Report No. 21214714**

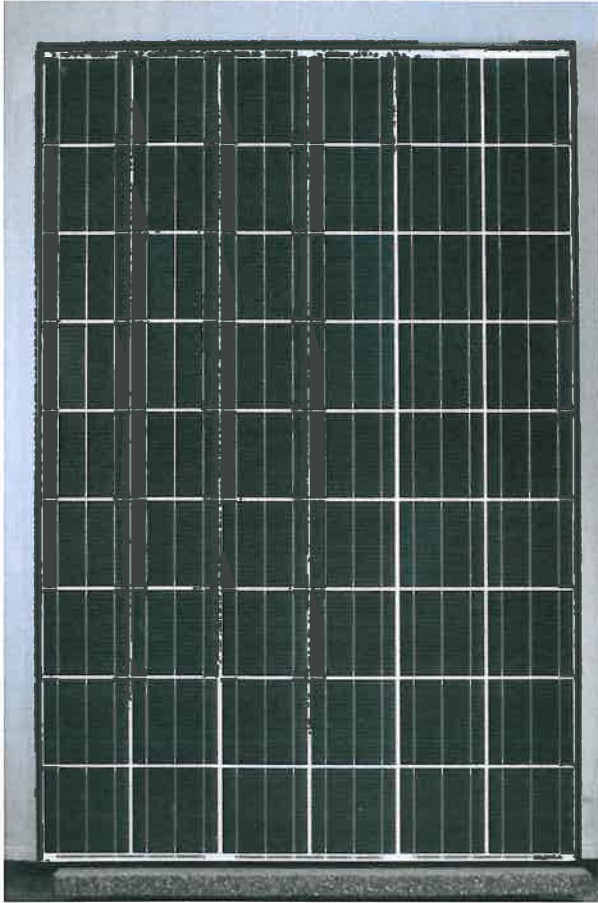
Fig. 1: front view of test sample

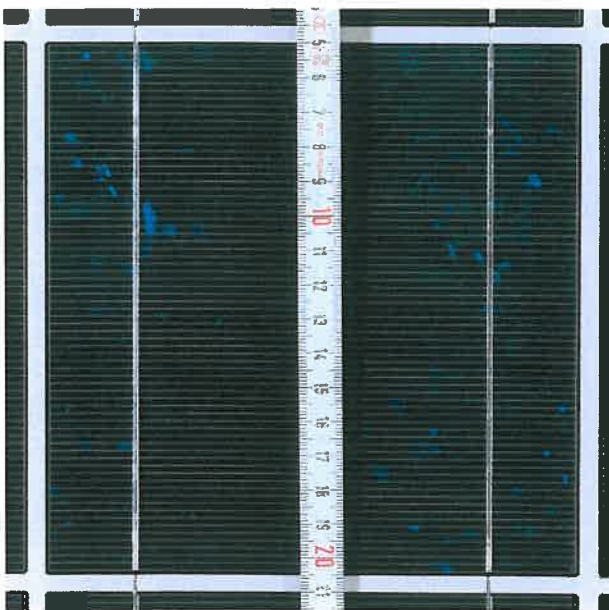
Fig. 3: detail view of solar cell

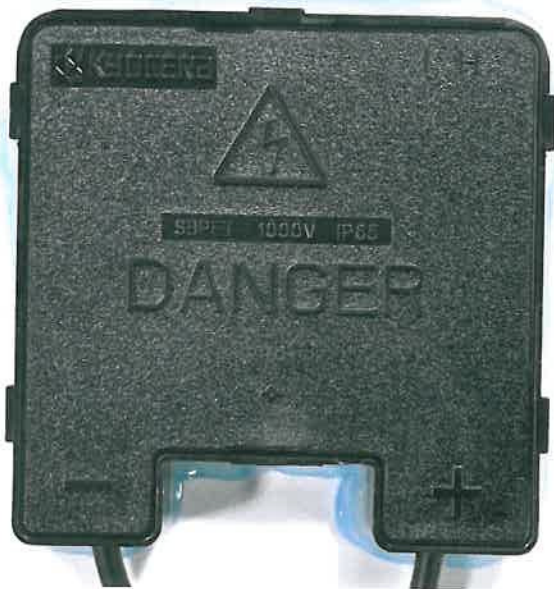
Fig. 5: detail view of closed junction box

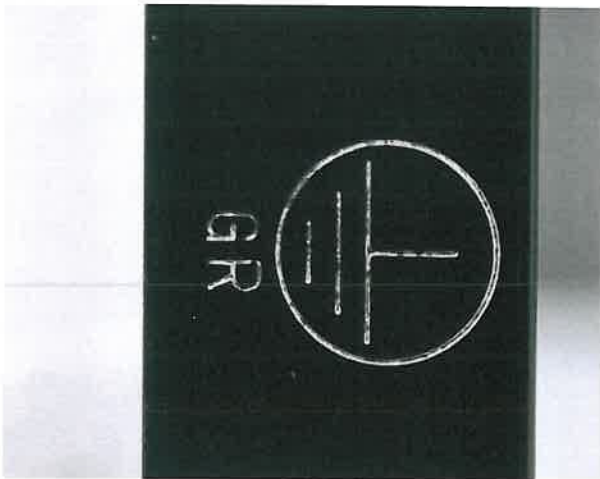
Fig. 7: detail view of grounding marking

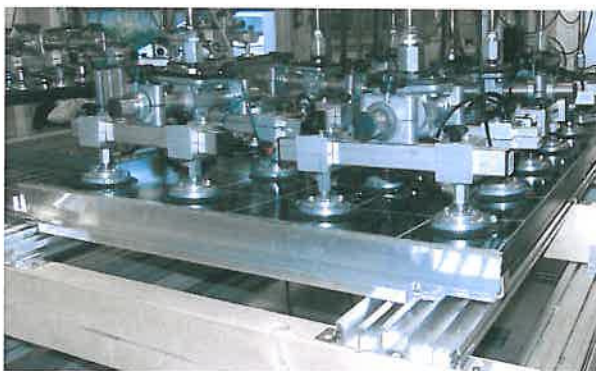
Fig. 9: Mechanical Load

The mechanical load test was performed on Kyocera, KD 215 GH-2 PU PV-Modules, mounted on TRI-ROOF mounting system. The installation was done according to the installation manual with one module. The mechanical load test with 2400 Pa and 5400 Pa were performed on different modules.

Test Date [DD/MM/YYYY].....	21.10.2010				—
Mechanical load applied to front side [Pa] .....	2400				—
Mechanical load applied to back side [Pa].....	2400				—
Sample #	Electrical continuity of module during the test (open circuits or no)				
20100005385	Yes				P
Supplementary information: Load was applied pneumatically;

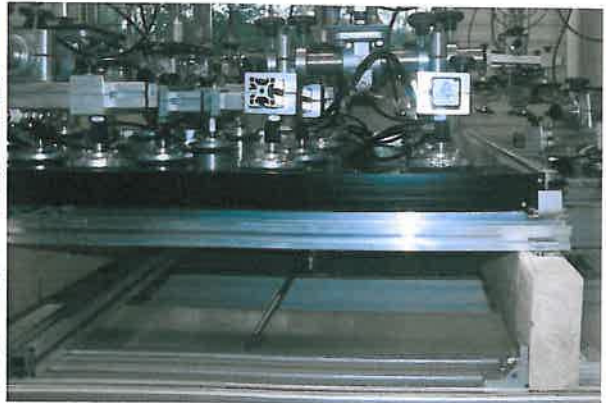
Fig. 10: Mechanical Load

AN extension to heavy snow load with 5400 Pa was also performed, while the module was supported by an additional profile.

Test Date [DD/MM/YYYY] .....				25.10.2010		—
Mechanical load applied to front side [Pa] .....				2400 / 5400		—
Mechanical load applied to back side [Pa] .....				2400		—
Sample #	Electrical continuity of module during the test (open circuits or no)					Verdict
20100005386	Yes					P
Supplementary information: Load was applied pneumatically;
